Prepared for: Town of Wrentham

Craig Wood ESS Group, Inc.

Presentation to Wrentham Board of Selectmen May 4, 2021

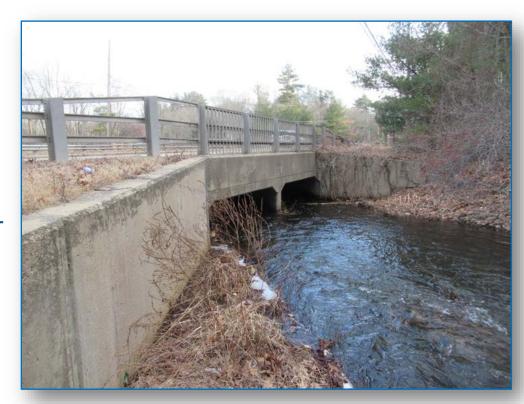
- Completed for 25, 50 and 100-year storm events using both 1992 rainfall data from Red Dam restoration study and current rainfall data (Northeast Regional Climate Center)
- While meeting MassDOT Principal Arterial design criteria, dam removal with historic rainfall raised 50 and 100-year storm water surface elevations at the Route 140 crossing
- Using current rainfall data, both existing conditions and dam removal overtopped Route 140 during 100year storm event
- More robust analysis (coordinated with MassDOT) is warranted to confirm initial results and determine if increased hydraulic capacity may be required at Route 140

Upstream view of Rt 140 crossing (twin 8 x 4 ft box culverts)

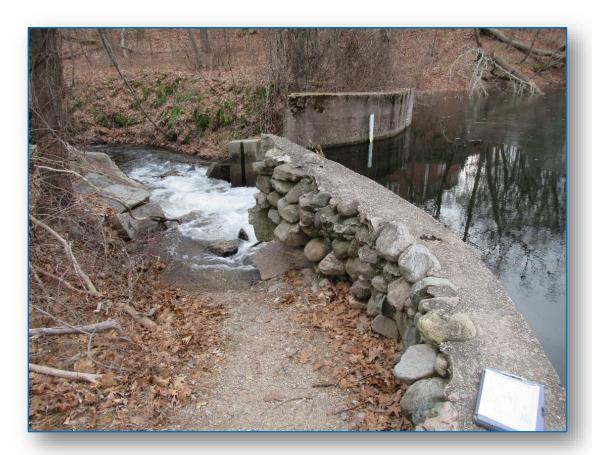
Eroded embankment west of spillway
