MEMORANDUM

FROM: Weston & Sampson

DATE: April 12, 2023, Updated May 24, 2023

SUBJECT: Eagle Dam Removal Phase II
Sub-task 3.1: Field “Survey” and “Investigations”

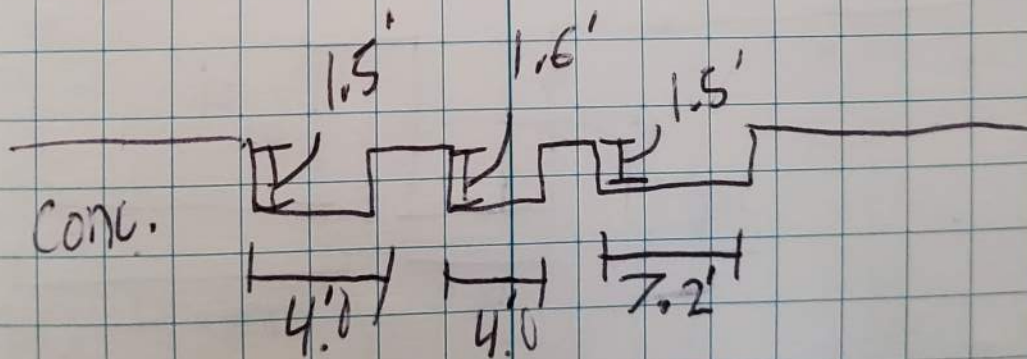
⑨ Bush Pond Dam
- foot bridge over spillways, 1' deck

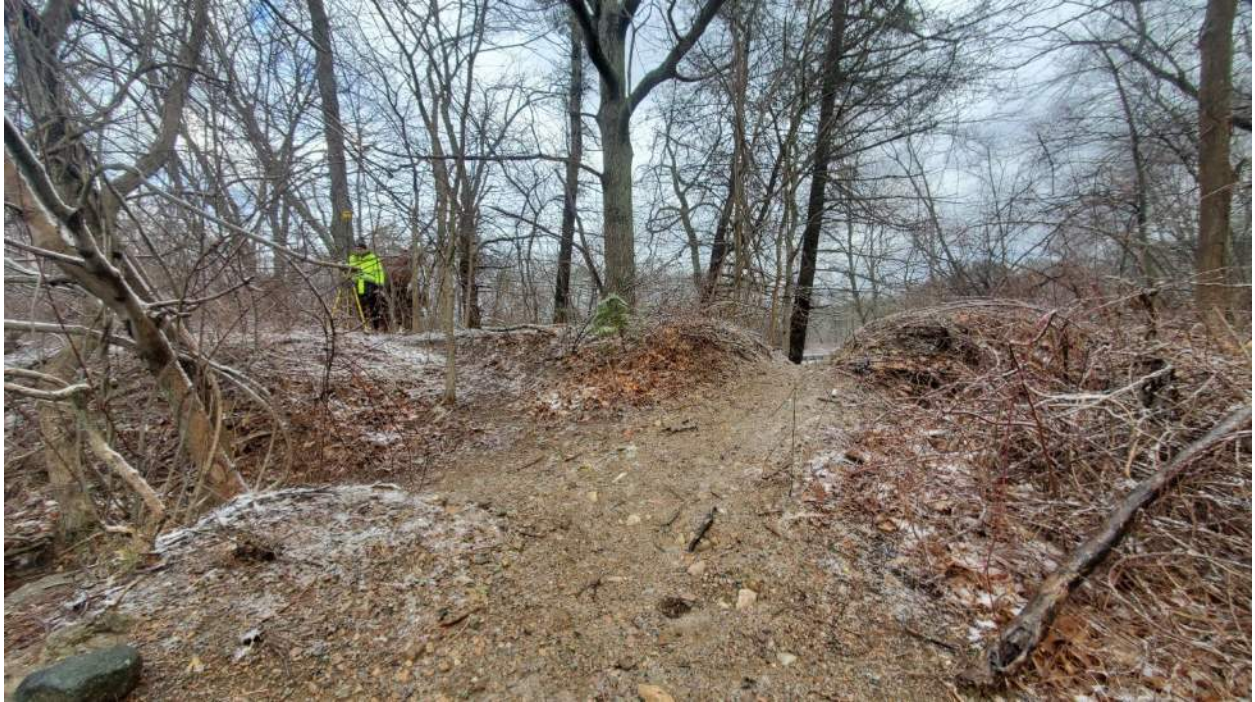
Photo 1: Eagle Lake Dam (MA02263) Embankment looking downstream. Eagle Lake Dam's embankment ungulates with several eroded walking paths, as seen in this photo.

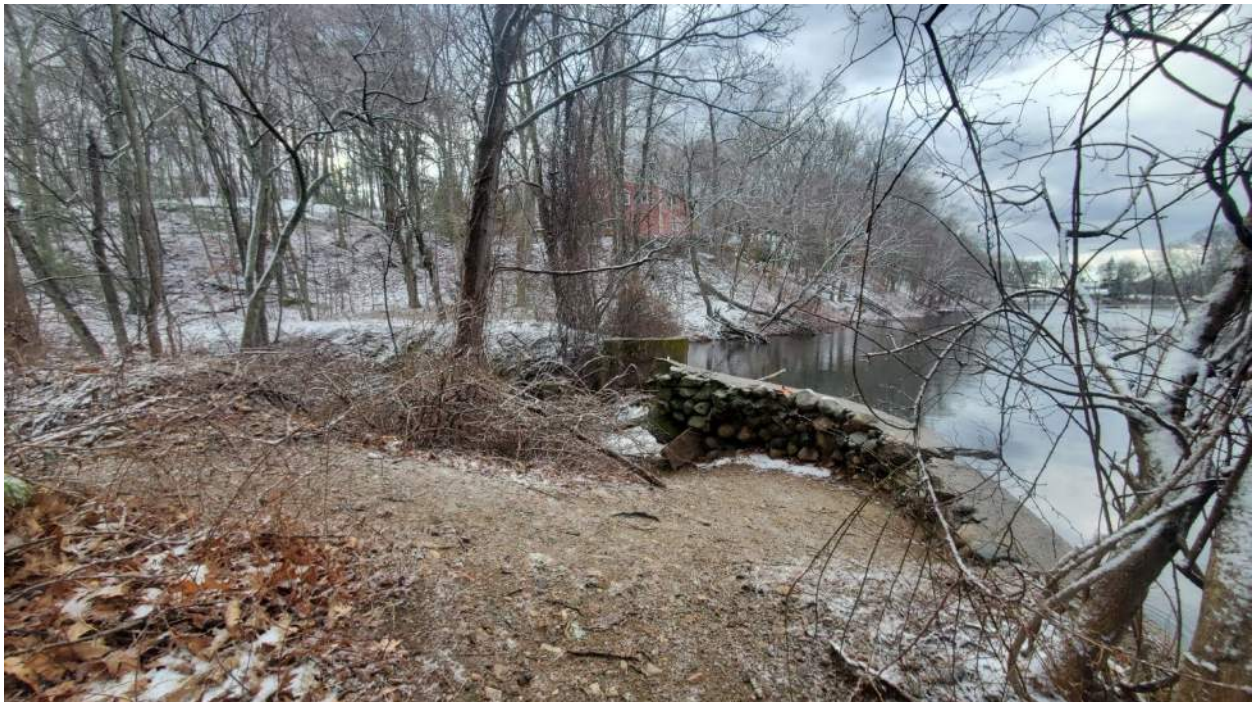
Photo 2: Eagle Lake Dam (MA02263) looking upstream at the primary spillway.

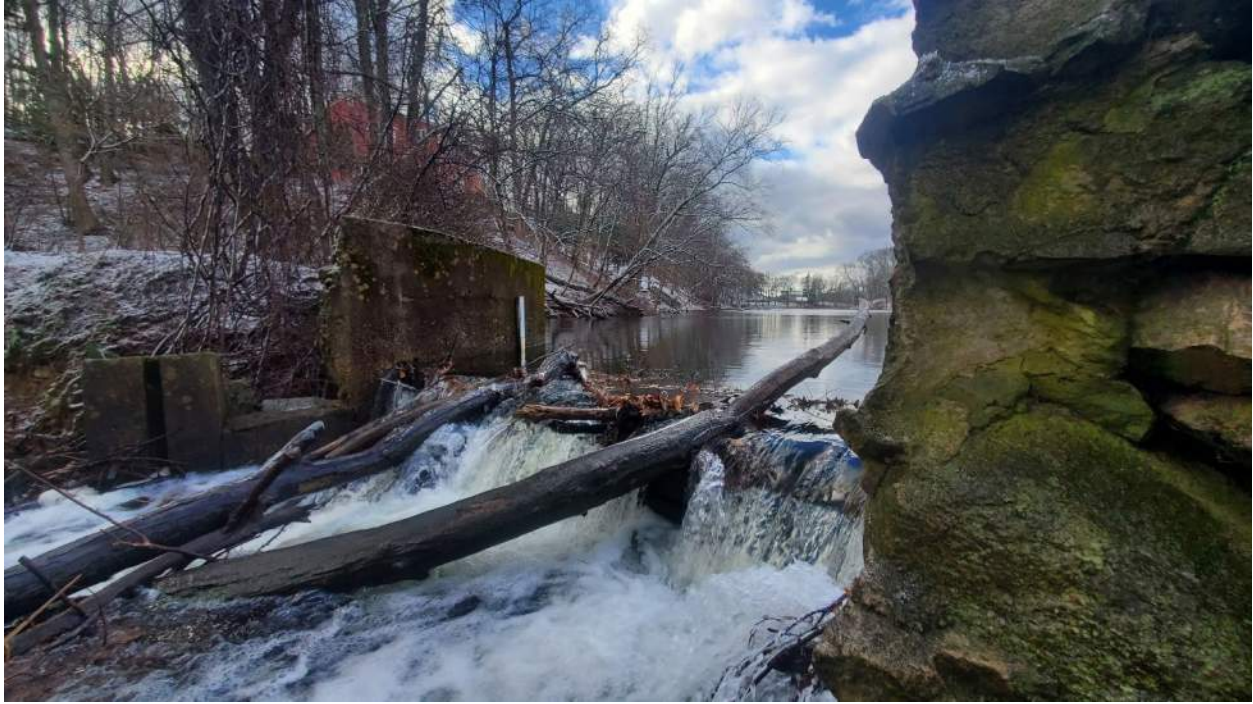
Photo 3: Eagle Lake Dam's (MA02263) primary spillway looking upstream. A staff gage is located on the right training wall.

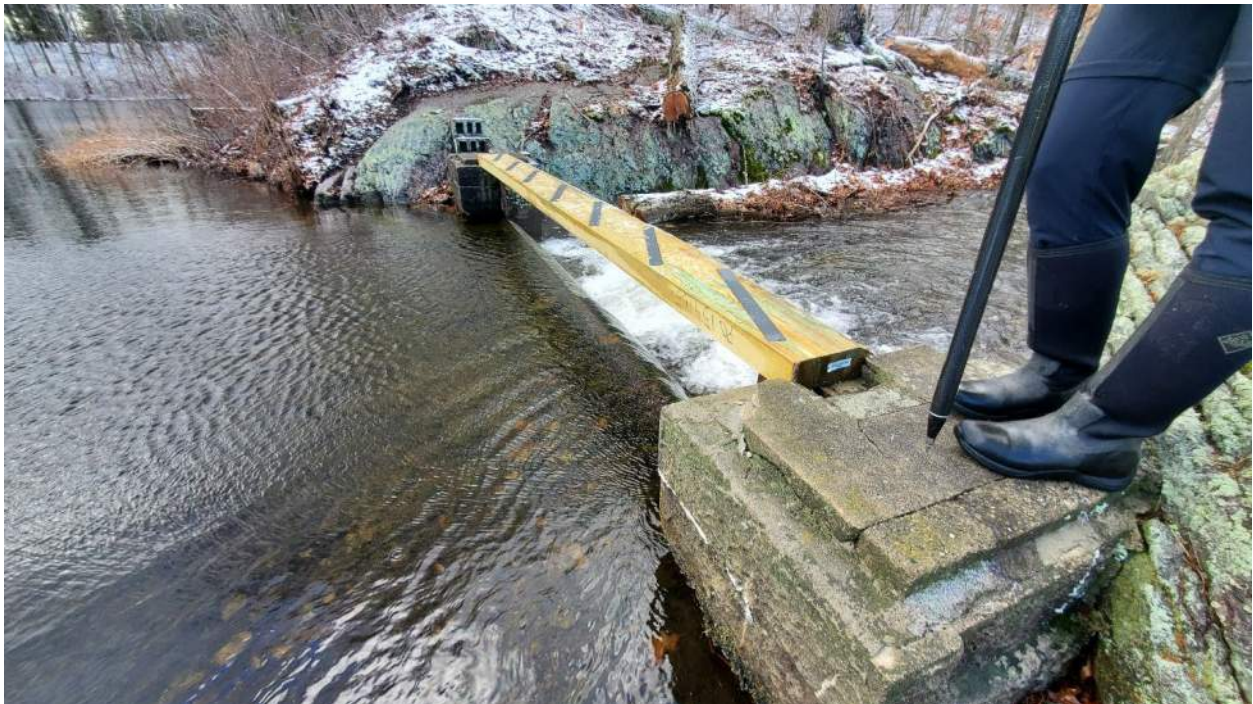
Photo 4: Unnamed dam at Mill Pond primary spillway. The primary spillway appeared to be a broad crested weir with a fixed angle iron.

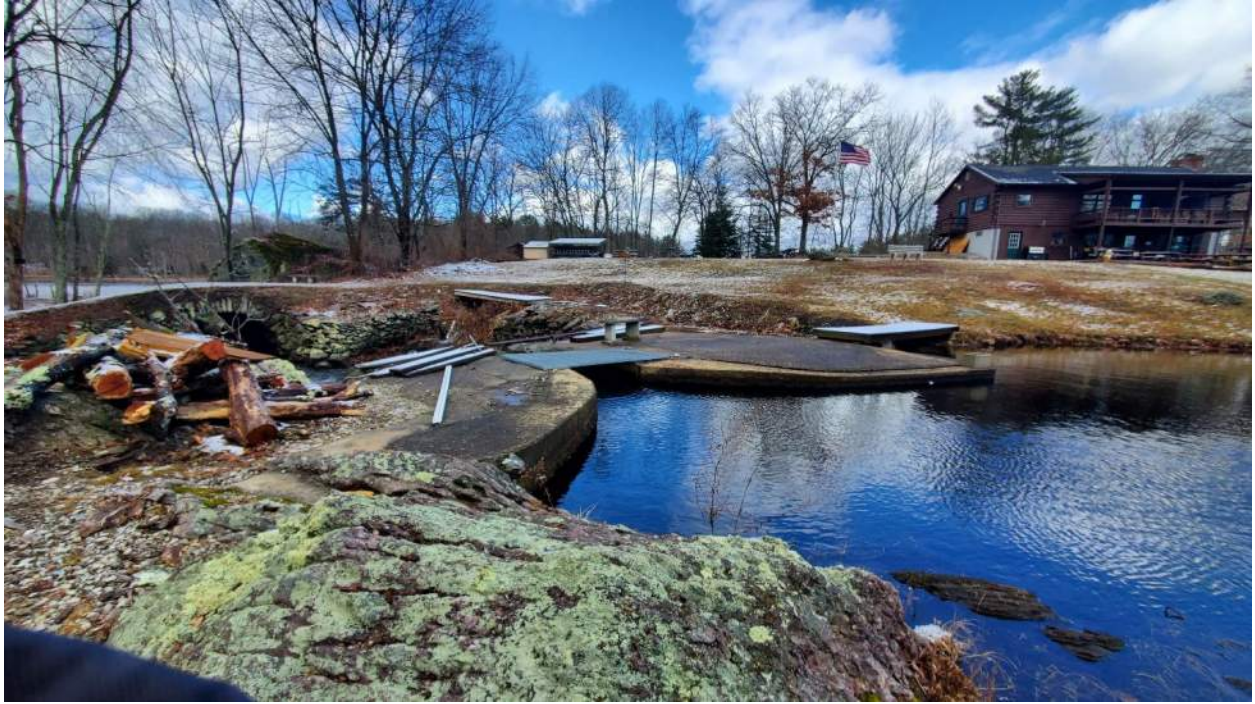
Photo 5: Unnamed dam at Mill Pond looking at the two auxiliary spillways from the right abutment of the primary spillway. The left auxiliary spillway is a stoplog-controlled channel, and the right auxiliary spillway is an earthen channel.

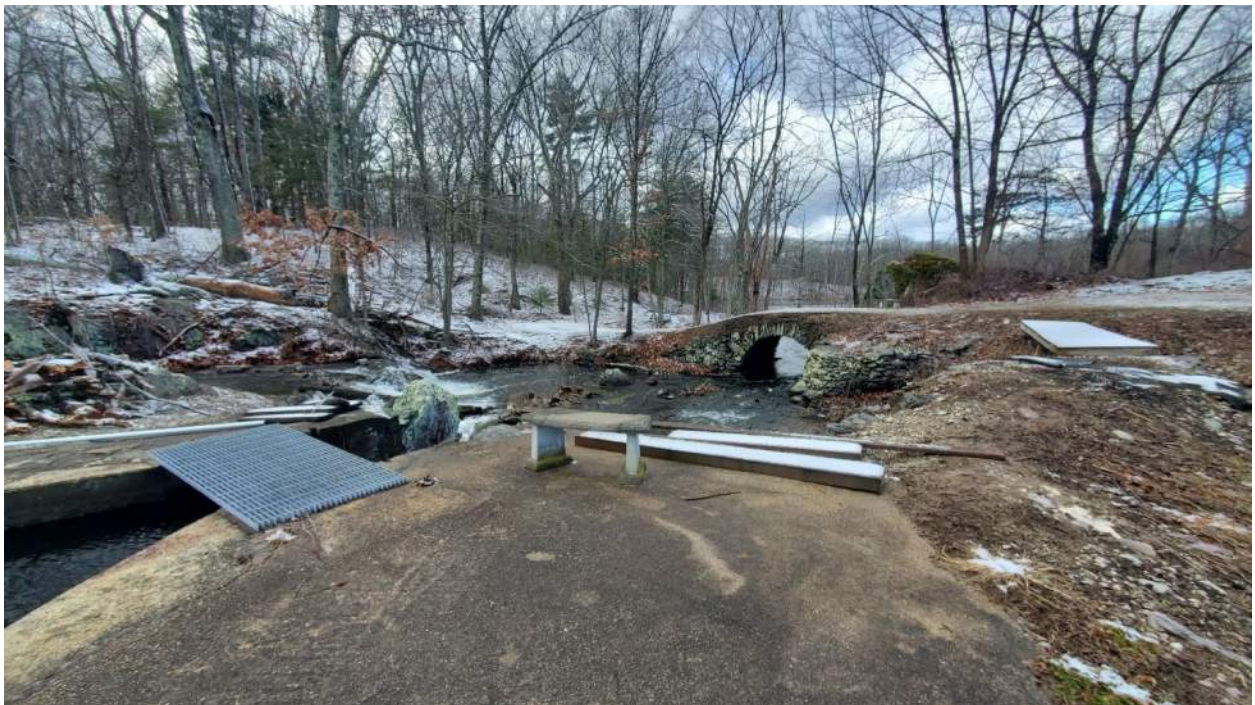
Photo 6: Unnamed dam at Mill Pond looking downstream at the stone culvert crossing downstream of the dam. The left auxiliary spillway is pictured above, with the right auxiliary spillway off-camera to the right.

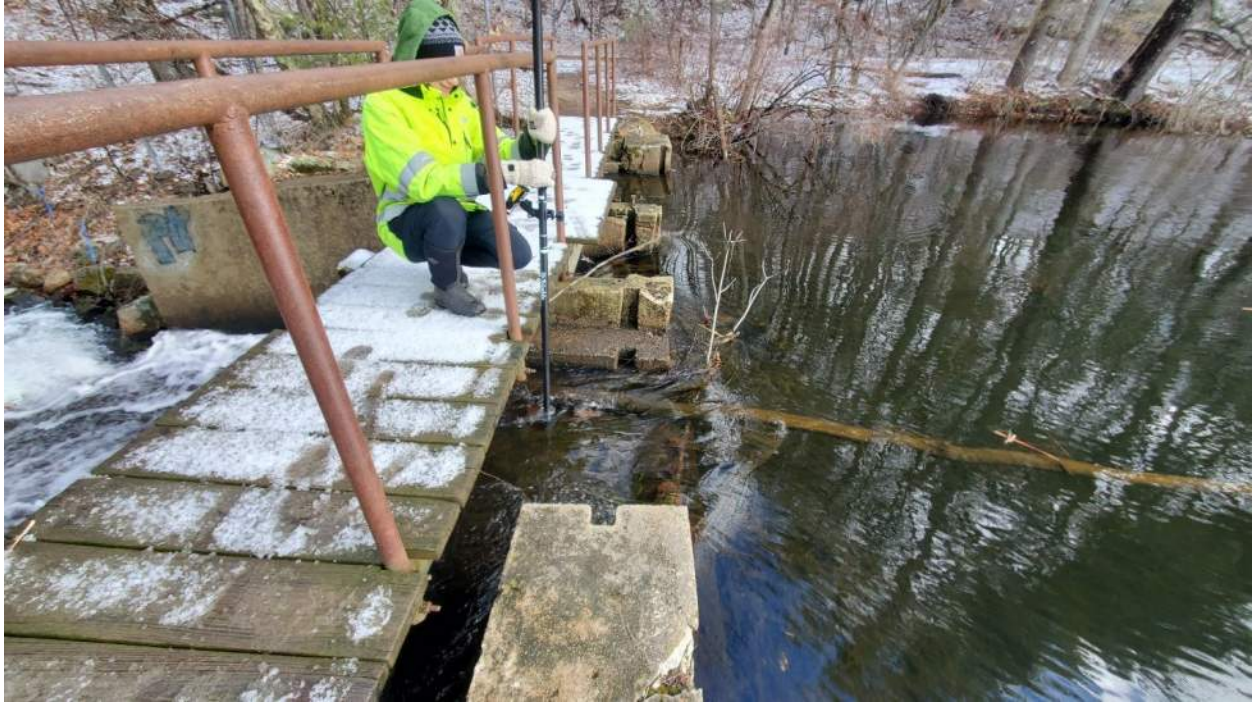
Photo 7: Bush Pond Dam (MA01158) looking at the spillways from the dam embankment. The spillways consisted of three stoplog-controlled channels.

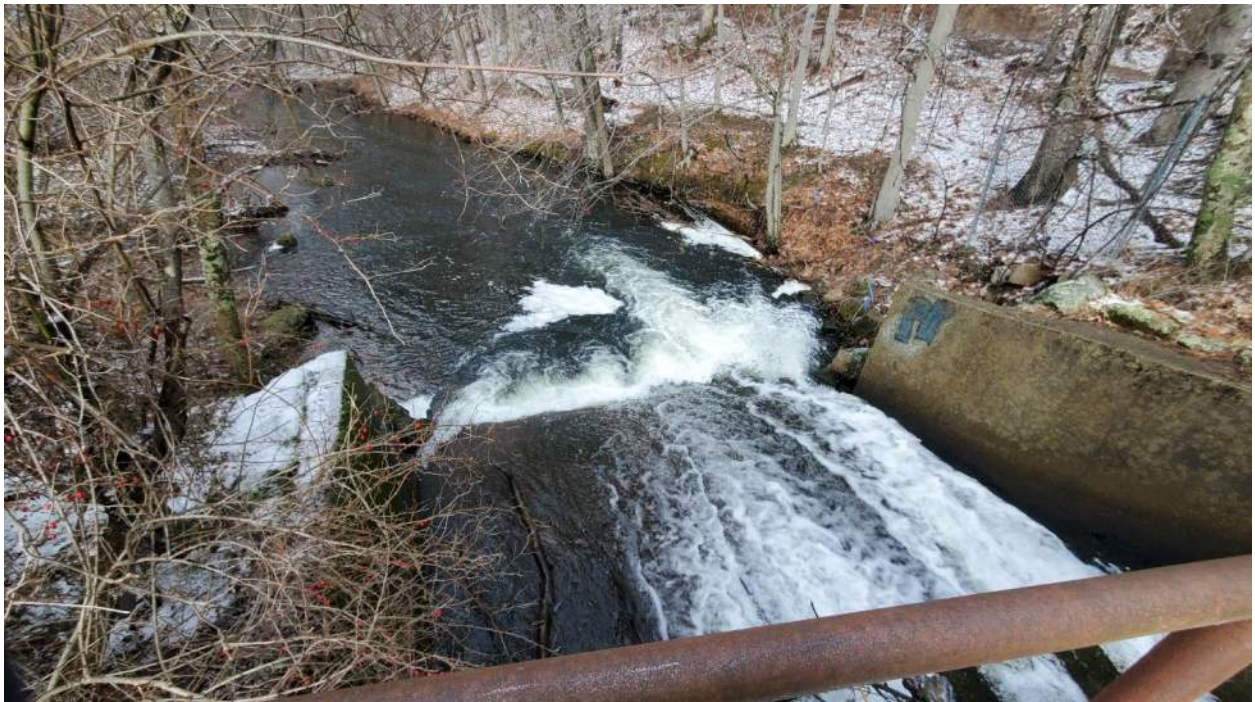
Photo 8: Bush Pond Dam (MA01158) looking downstream at the discharge channel from the pedestrian bridge above the spillways.

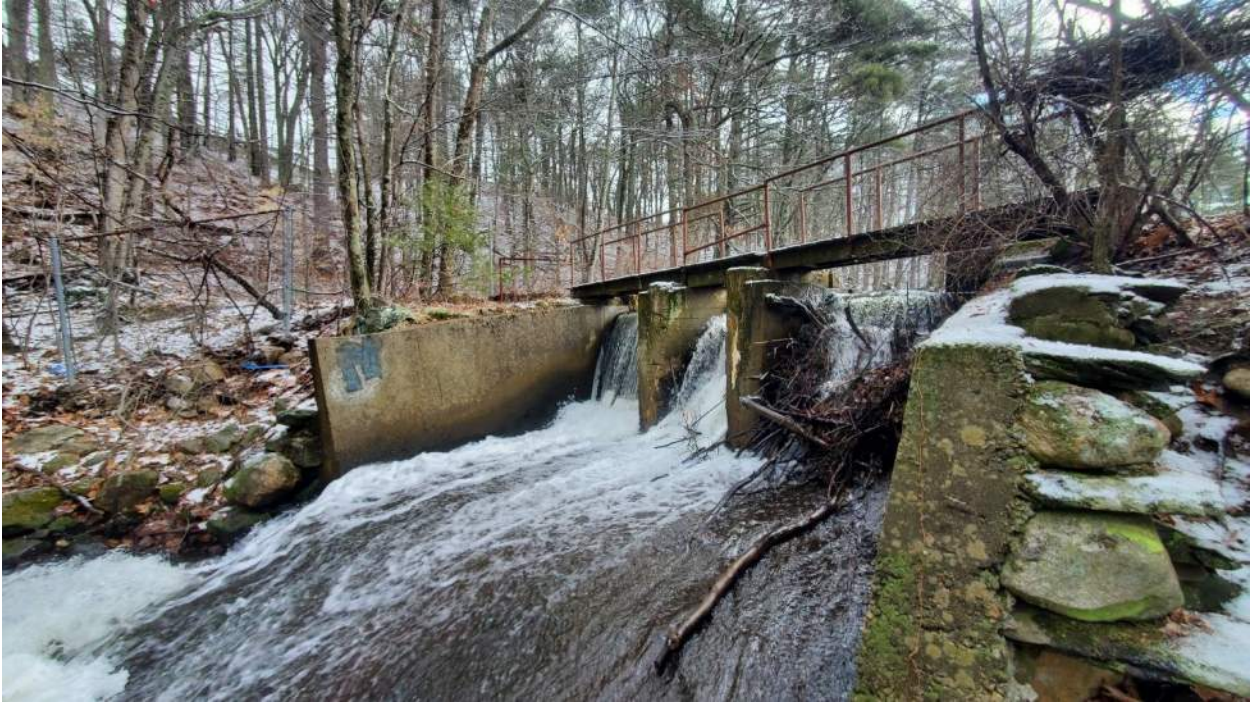
Photo 9: Bush Pond Dam (MA01158) looking upstream at the spillways from the toe of the dam.

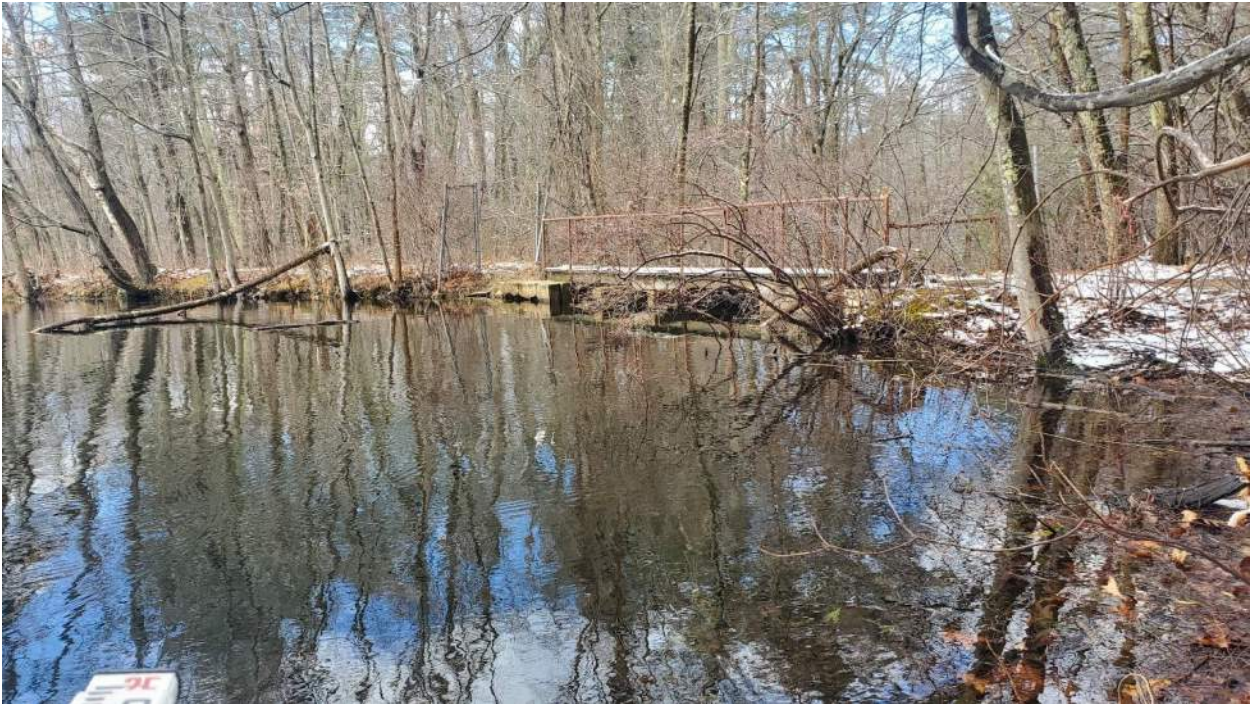
Photo 10: Bush Pond Dam (MA01158) looking at the upstream face of the spillways and dam embankment from the edge of Bush Pond.
