Eagle Dam Phase I Inspection / Evaluation Report

Wrentham, Massachusetts

Dam Name: **Eagle Dam**NID ID#: **MA02263**

Date of Inspection: October 11, 2022

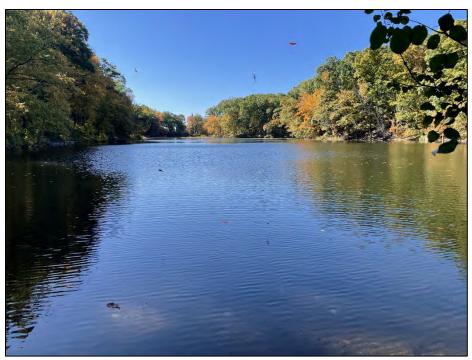
Photo No. 1.: Overview of the impoundment from near Sta. 1+50 looking upstream.

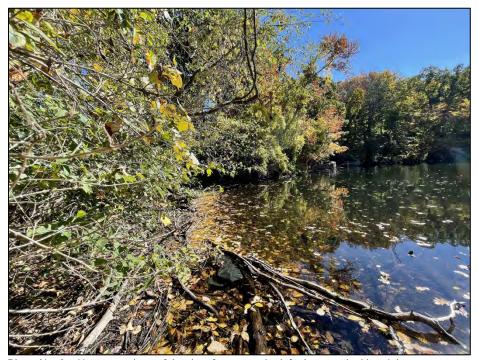
Photo No. 2.: Upstream slope of the dam from near the left abutment looking right.

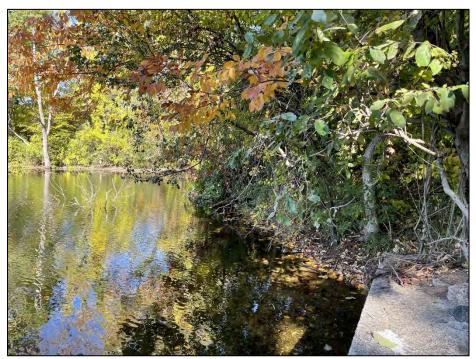
| A | The upstream slope transitions to masonry wall from 1+30 to 1+50, with a worn path around the left end of the wall. The wall is in poor condition and has failed at the transition to the left training wall. | | The upstream wall continued to deteriorate; the worn path extended to the downstream channel. A 16-inch wide by 8-inch-deep void followed by a crack was noted approximately mid-wall. |

Photo No. 3.: Upstream slope from the left side of the spillway near Sta. 1+30 looking left.

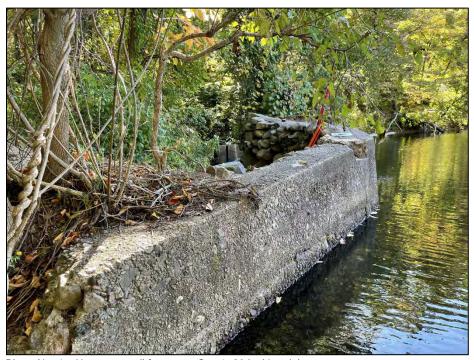
Photo No. 4.: Upstream wall from near Sta. 1+30 looking right.

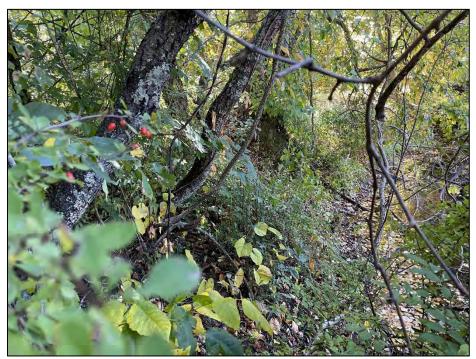
| A | The upstream slope transitions to masonry wall from 1+30 to 1+50, with a worn path around the left end of the wall. The wall is in poor condition and has failed at the transition to the left training wall. | | The upstream wall continued to deteriorate; the worn path extended to the downstream channel. A 16-inch wide by 8-inch-deep void followed by a crack was noted approximately mid-wall. |
|---|---|---|---|
| A | Right of the spillway, the upstream slope is near vertical, with tree and brush coverage from the wall to the right abutment. | > | Appeared in similar condition as previously noted with vegetation continuing to grow unchecked and erosion continuing to develop. |

Photo No. 5.: Upstream slope of the dam right of the spillway.

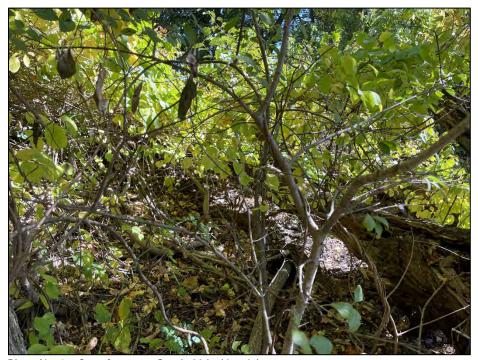
Photo No. 6.: Crest from near Sta. 0+00 looking right.

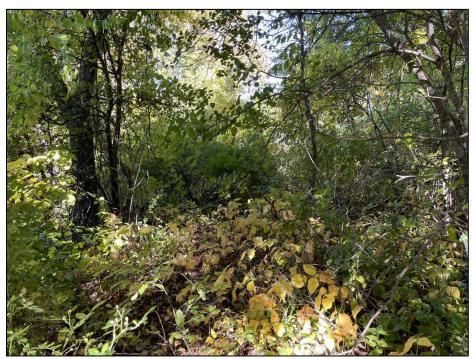
Photo No. 7.: Crest from near Sta. 1+00 looking left.

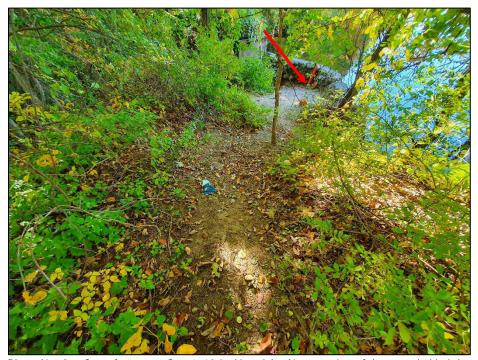
| Cu | Current Observations: | | | | |
|---|--|--|--|--|--|
| > | At 1+10 the dam crest approximately 6' to the eroded area that extends to the water edge. | ➤ Appeared in similar condition as previously noted. | | | |

Photo No. 8.: Crest from near Sta. 1+10 looking right. Note erosion of the crest behind the upstream wall left of the spillway (arrow).

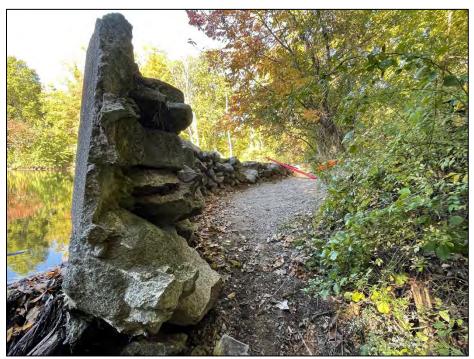
| Cu | Current Observations: | | | | |
|---|--|--|--|--|--|
| > | The concrete and masonry downstream and upstream walls area 18" thick and approximately 20' long with a curved alignment. It was noted that the downstream side is fully eroded behind wall. | ➤ The concrete and masonry wall continued to erode/degrade; vines and brush growth were noted behind the wall. | | | |

Photo No. 9.: Erosion of the dam crest immediately behind the upstream wall left of the spillway.

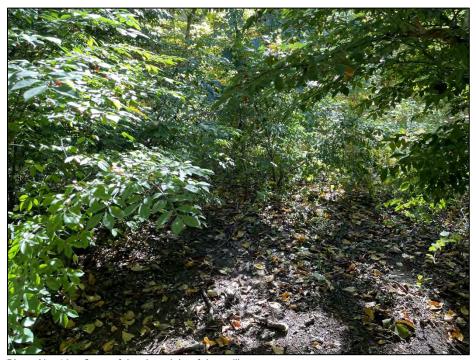
| Cu | Current Observations: | | | | |
|---|--|--|--|--|--|
| > | Right of the spillway, the crest has an average width of 5'± at abutment with a large 24" tree located at upstream edge of crest. | Appeared in similar condition as previously noted. | | | |

Photo No. 10.: Crest of the dam right of the spillway.

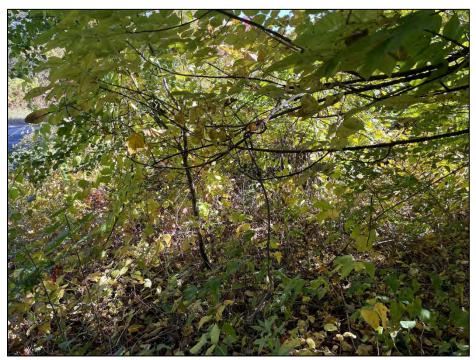
Photo No. 11.: Downstream slope from near the left abutment looking left.

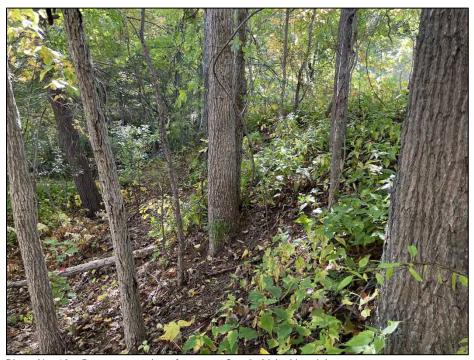
Photo No. 12.: Downstream slope from near Sta. 0+80 looking right.

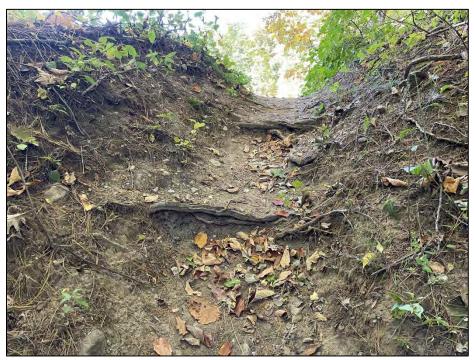
Photo No. 13.: Erosion path from the crest to downstream toe near Sta. 1+00.

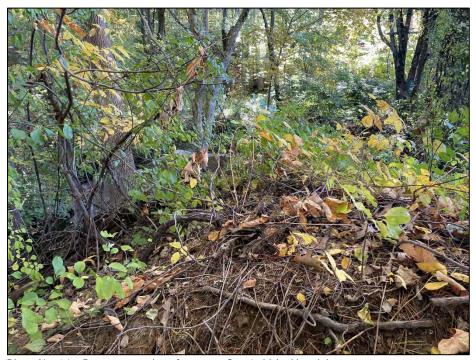
| > | Between Sta. 0+25 to Sta. 0+50, the downstream slope steepens to 2H:1V with increasing vegetation and a tree at the toe of the slope at STA 0+30±. | ➤ Trees was noted throughout. |
|---|--|--|
| > | Between Sta. 1+00 to Sta. 1+25, the downstream side of the dam in this area is pitched 1H:V1, with 6-8" trees noted throughout. | Appeared in similar condition as previously noted with trees continuing to increase in diameter. |

Photo No. 14.: Downstream slope from near Sta. 1+00 looking right.

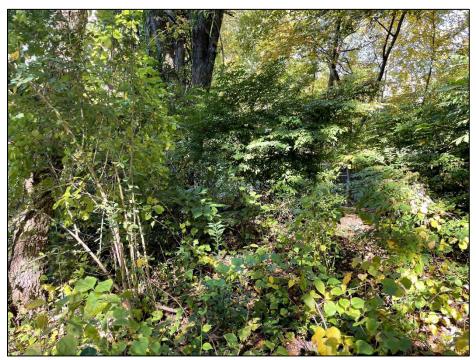
| > | Between Sta. 0+25 to Sta. 0+50, the downstream slope steepens to 2H:1V with increasing vegetation and a tree at the toe of the slope at STA 0+30±. | ➤ Trees was noted throughout. |
|---|--|--|
| > | Right of the spillway, the short section of downstream slope is near vertical, and moss covered. | ➤ Appeared in similar condition as previously noted. |

Photo No. 15.: Downstream slope right of the spillway.

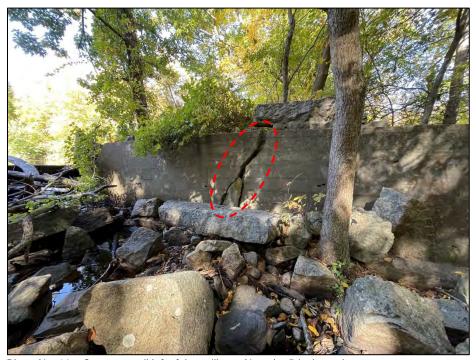
| Current Observations: | | | | |
|---|---|--|--|--|
| The downstream wall left of the spillway is in poor condition with cracks up to 5-in wide extend along the height of the wall at mid-section. | | | | |

Photo No. 16.: Concrete wall left of the spillway. Note the 5-inch crack.

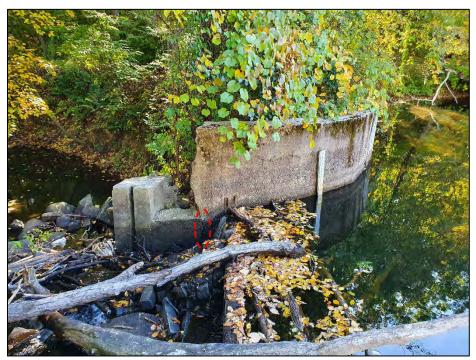
| R | eview of Previous Observations: | Comments from Current Inspection: | | | |
|---|--|--|--|--|--|
| A | The left and right training walls have failed. | ➤ The left and right training wall continue to deteriorate with vertical cracks along th wall, spalls, missing section, and areas o scour. | | | |

Photo No. 17.: Overview of the right upstream wall from the spillway channel looking right. Note the crack along the downstream section.

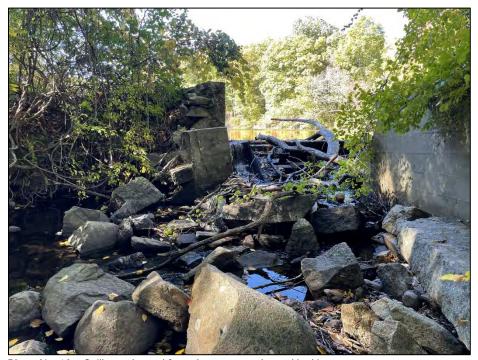
| R | eview of Previous Observations: | Comments from Current Inspection: | | | |
|---|--|--|--|--|--|
| > | There was stones and masonry debris in channel, presumable from the previously failed structure. | Appeared in similar condition a previously noted. | | | |

Photo No. 18.: Spillway channel from downstream channel looking upstream.

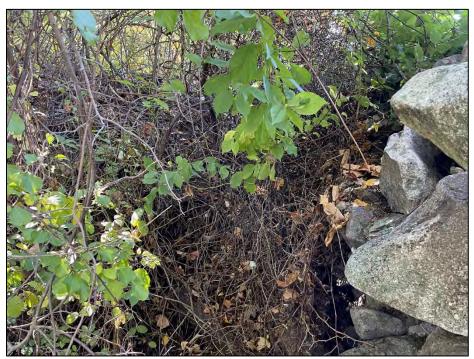
| R | eview of Previous Observations: | Comments from Current Inspection: | | | |
|---|--|--|--|--|--|
| > | Significant erosion was noted behind the right training wall. | Severe vertical erosion was noted behind the left and right training walls. | | | |

Photo No. 19.: Eroded area behind the right upstream wall.

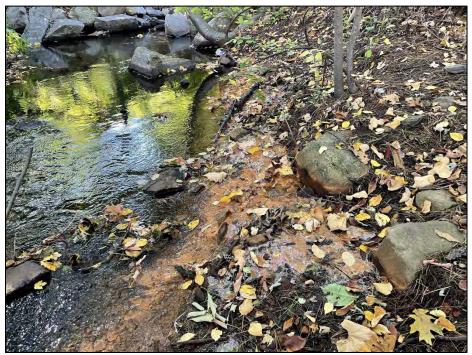
- Two areas of seepage were noted downstream of the spillway
 - o Approximately 15 feet downstream, left of the channel, 0.2 GPM, no sign of sediment transport, stained iron oxide was observed.
 - o Approximately 20 feet downstream, left of the channel, 1 GPM, no sign of sediment transport, stained iron oxide was observed.
- Leakage was noted between the stacked stones forming the spillway control section.
- > Sticks, logs, and other debris is present within the downstream area approximately 20 to 30-feet downstream of the dam. This debris is creating a 2-foot tailwater within the discharge area.

Based on a visual assessment of the dam, while no signs of sediment transport were apparent, the seepage downstream of the spillway, is condition that may contribute to internal erosion and/or piping, which can lead to further deterioration of the structure including the development of sinkholes and voids within the embankment, or failure of the structure.

Photo No. 20.: Observed seepages with iron oxide flocculant approximately 15 feet downstream of the downstream channel left wall.

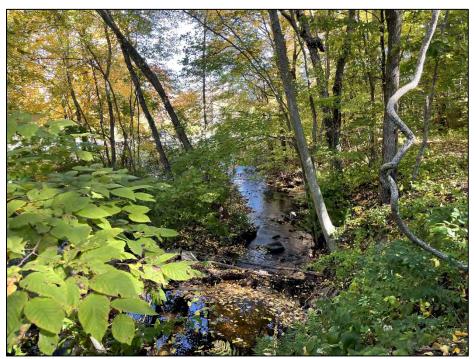
Photo No. 21.: Downstream view of the Eagle Brook

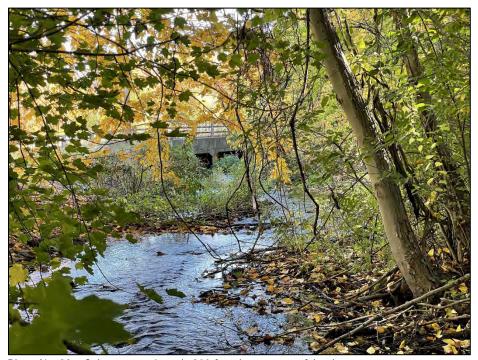
Photo No. 22.: Culvert approximately 200-feet downstream of the dam.
