**Bacterial Assessment:**  
Winter Hill Brook, Medford;  
Ell Pond, Melrose;  
Sales Creek and Belle Isle Inlet, Revere

**Report Date: September 11, 2007**

*Technical Report # 9-004*

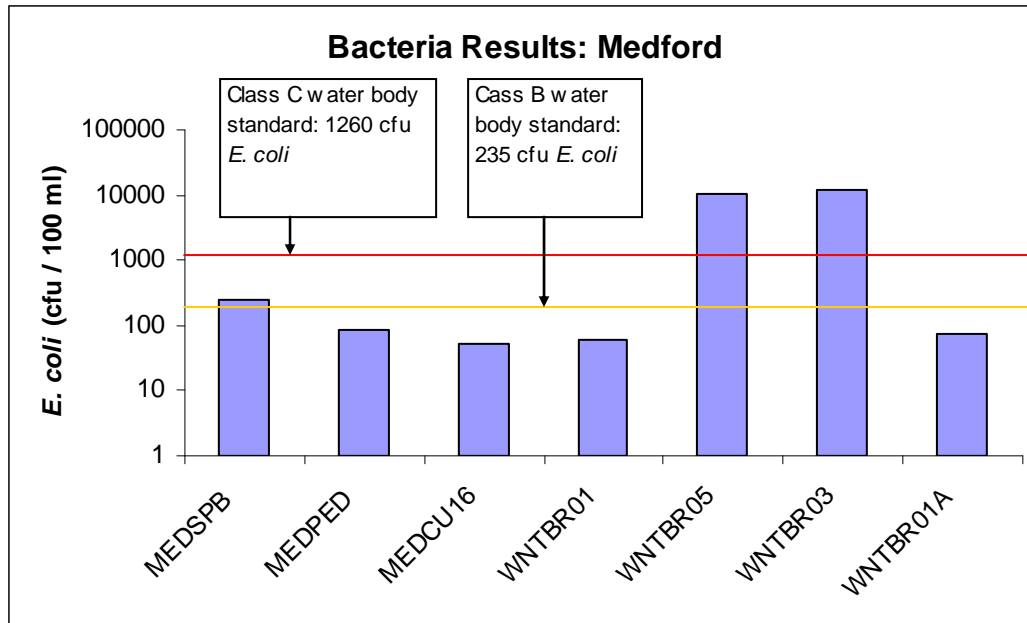
Figure 1. Bacteria counts from samples collected in Medford on 27 June 2007. Three of seven samples failed to meet the state water quality bacteria standard for a Class B water body (235 cfu / 100 ml). Two samples collected from Winter Hill Brook also exceeded the bacteria limit for a Class C water body (1260 cfu *E. coli*).

Three out of seven samples collected in Medford failed to meet water quality standards. Two of these samples were taken from Winter Hill Brook, and were 44 – 51 times the allowable limit of bacteria. WNTBR03, the highest of the two, was collected downstream of the Rt. 38 bridge over Winter Hill Brook. WNTBR05 was a centerline sample upstream of the Rt. 38 bridge. Unacceptably high levels of bacteria have been found in Winter Hill Brook on other occasions as well (see data online from 6/15/05 and 1/23/07). An unacceptably high bacteria count was also detected behind the State Police building at the intersection of Rt. 28 and Rt. 16.

1. The source of bacteria in Winter Hill Brook needs to be identified. We recommend testing for optical brighteners to determine whether the bacteria are from sewage contamination or wildlife. Please contact us to discuss a strategy for accomplishing this task.
2. We recommend conducting water quality tests under sewer covers upstream from the culvert at Tremont Street that flows into Ell Pond to target the source of bacteria contamination. Please contact us to discuss how MyRWA can be of assistance.
3. Outfall pipes in Sales Creek near the trailer park off Rt. 1A should be sampled in order to identify the source of bacteria contamination to the creek.
4. We recommend that the towns of Medford, Melrose, and Revere conduct a public outreach campaign to educate citizens about bacteria contamination.

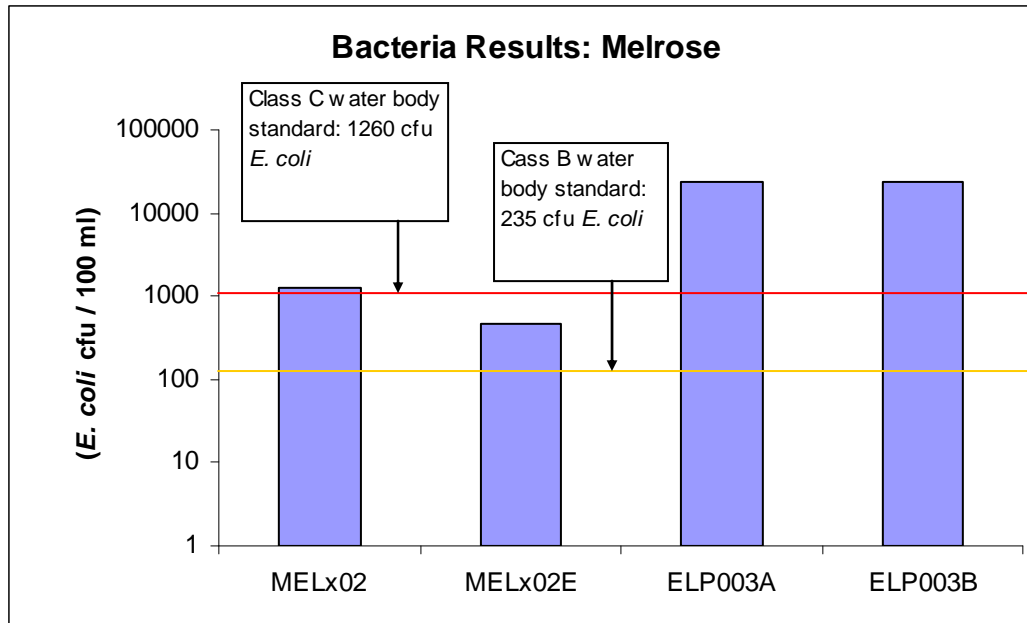
Figure 2. Samples collected on 27 June 2007 from EII Pond, a Class B water body in Melrose. All samples failed to meet the state water quality standard for *E. coli* for a Class B water body, and 3 samples failed to meet the standard for a Class C water body (235 cfu / 100 ml and 1260 cfu / 100 ml, respectively).

Four samples were collected in Melrose at Ell Pond and all failed to meet water quality standards. Two of these samples were collected from both sides of the double culvert at the head of the northern inlet to Ell Pond, off Lynn Fells Parkway. The western culvert tested higher than the eastern. Two samples were also collected near the swimming pool off Tremont St. A sample collected right at the base of an outfall pipe (ELP003A) tested above the maximum detection limit of our methods, at >24,196 cfu *E. coli*. Another sample (ELP003B) was collected slightly downstream, at the red pedestrian bridge, which also tested extremely high (24,196 cfu *E. coli*). MyRWA re-sampled ELP003A on July 25, 2007 using methods with a higher detection limit, and found that bacteria levels exceeded 241,960 cfu *E. coli* (details of this report are forthcoming). This is a dangerous level of bacteria contamination and the source of this contamination needs to be identified immediately.

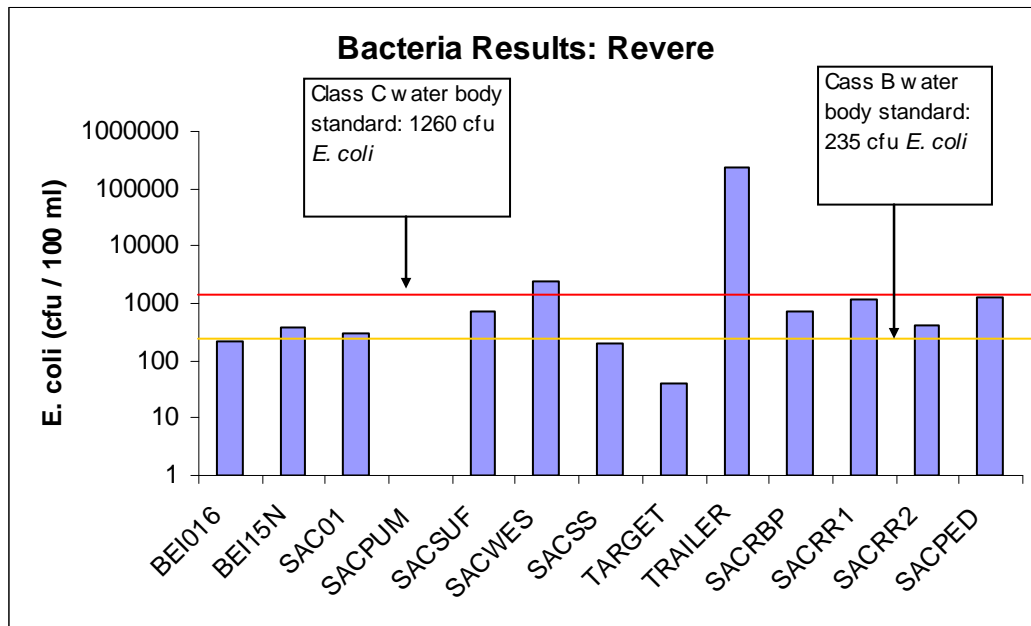
Figure 3. Samples collected on 27 June 2007 from Sales Creek and Belle Isle Inlet in Revere. Nine of thirteen samples failed to meet the state water quality standard for *E. coli* for a Class B water body, and two samples failed to meet the standard for a Class C water body (235 cfu / 100 ml and 1260 cfu / 100 ml, respectively).

In general, bacteria levels were very high in Revere, with nine out of thirteen samples exceeding allowable limits for bacteria. The worst of these samples was collected at Lee's Trailer Park on Green St. (near intersection of 1A and Revere Beach Parkway). This sample (TRAILER) exceeded the upper detection limit of both the MyRWA tests (>24,196 cfu *E. coli* / 100 ml) and the EPA tests (>241,920 cfu / 100 ml). One of MyRWA's monitors spoke with a construction worker near the creek, who reported a strong sewer smell coming from the water. These observations in combination with the alarmingly high bacteria concentrations at Sales Creek suggest the presence of a possible illicit connection.
