Eagle Dam Public Meeting

Eagle Dam

Phase I Inspection / Evaluation Report

Wrentham, Massachusetts

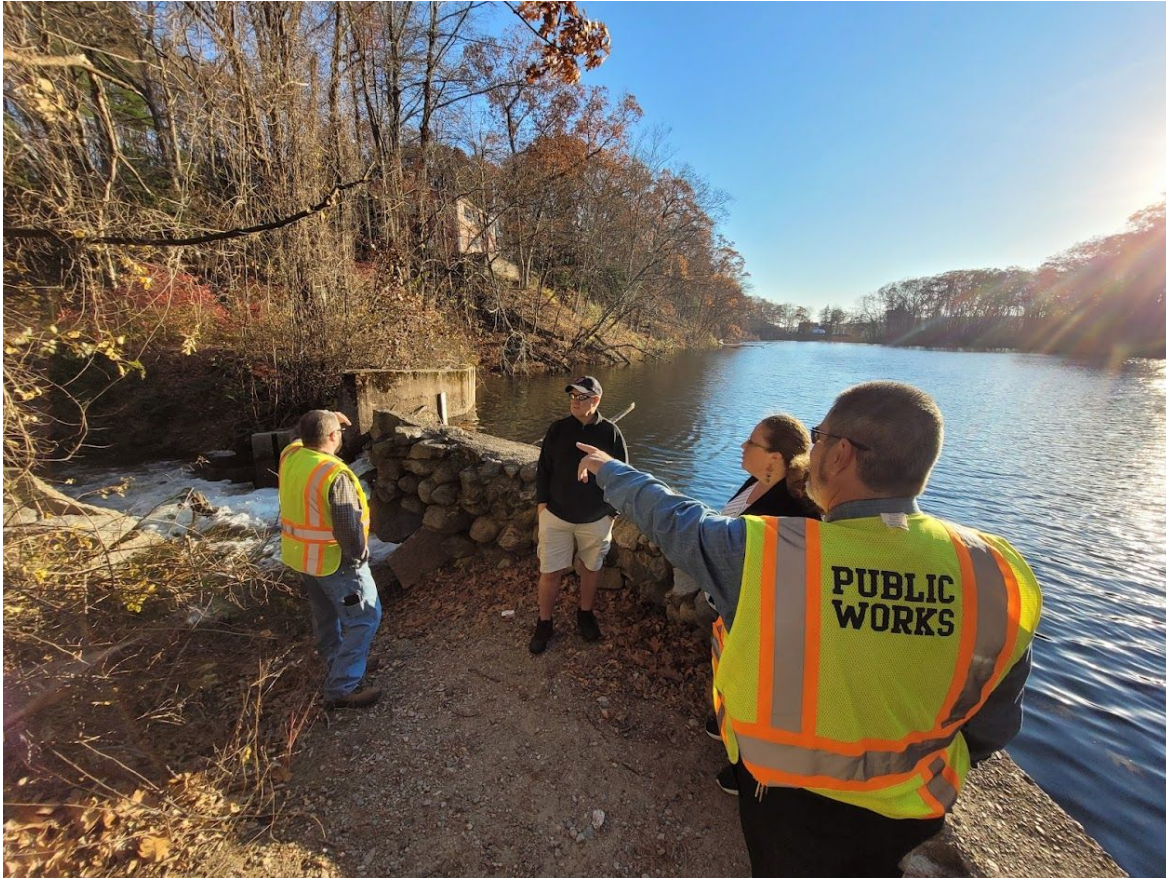
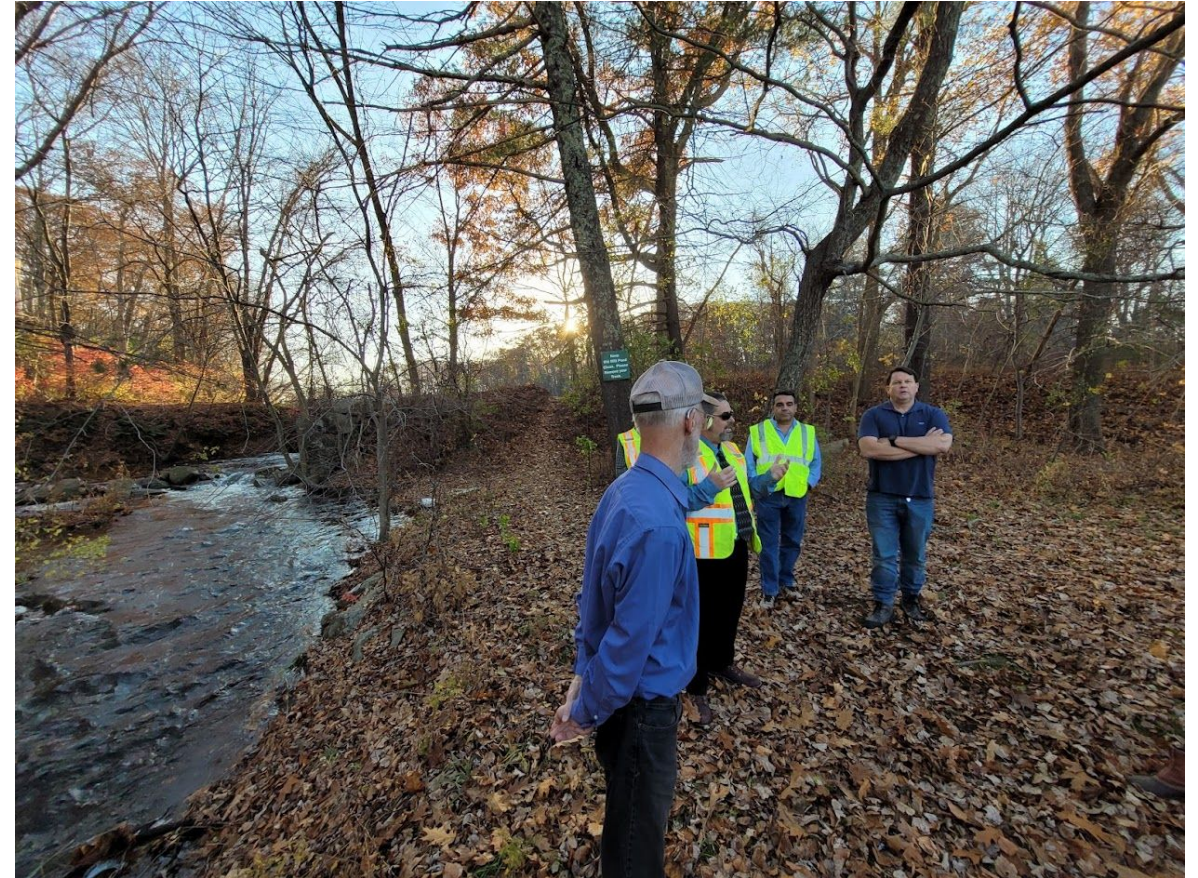
Eagle Dam, Wrentham

- Low Hazard Potential Structure in unsafe condition
- Owned by Town of Wrentham
- Trees growing in/on dam and water flowing through structure
- Identified in Wrentham Municipal Vulnerability Preparedness Plan

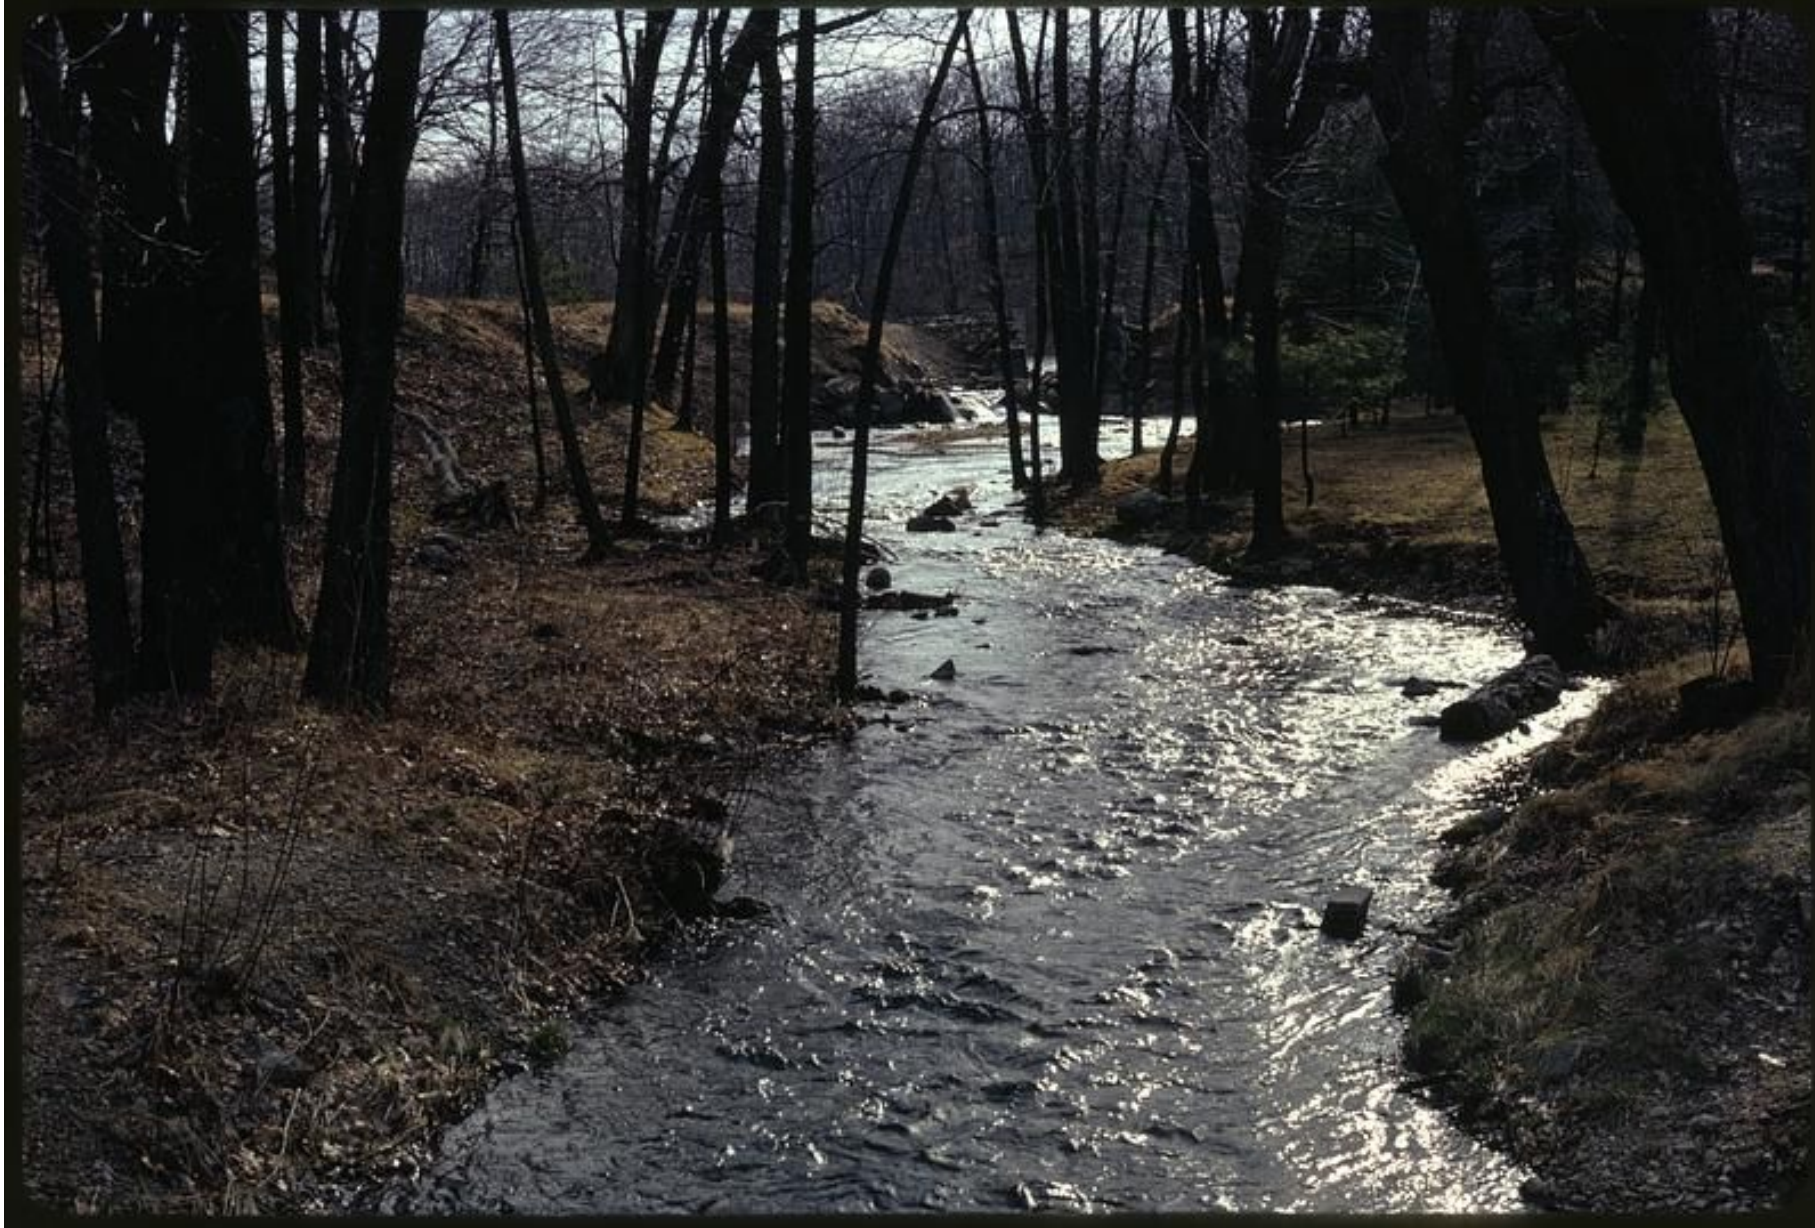
Eagle Dam Breached Condition 1973

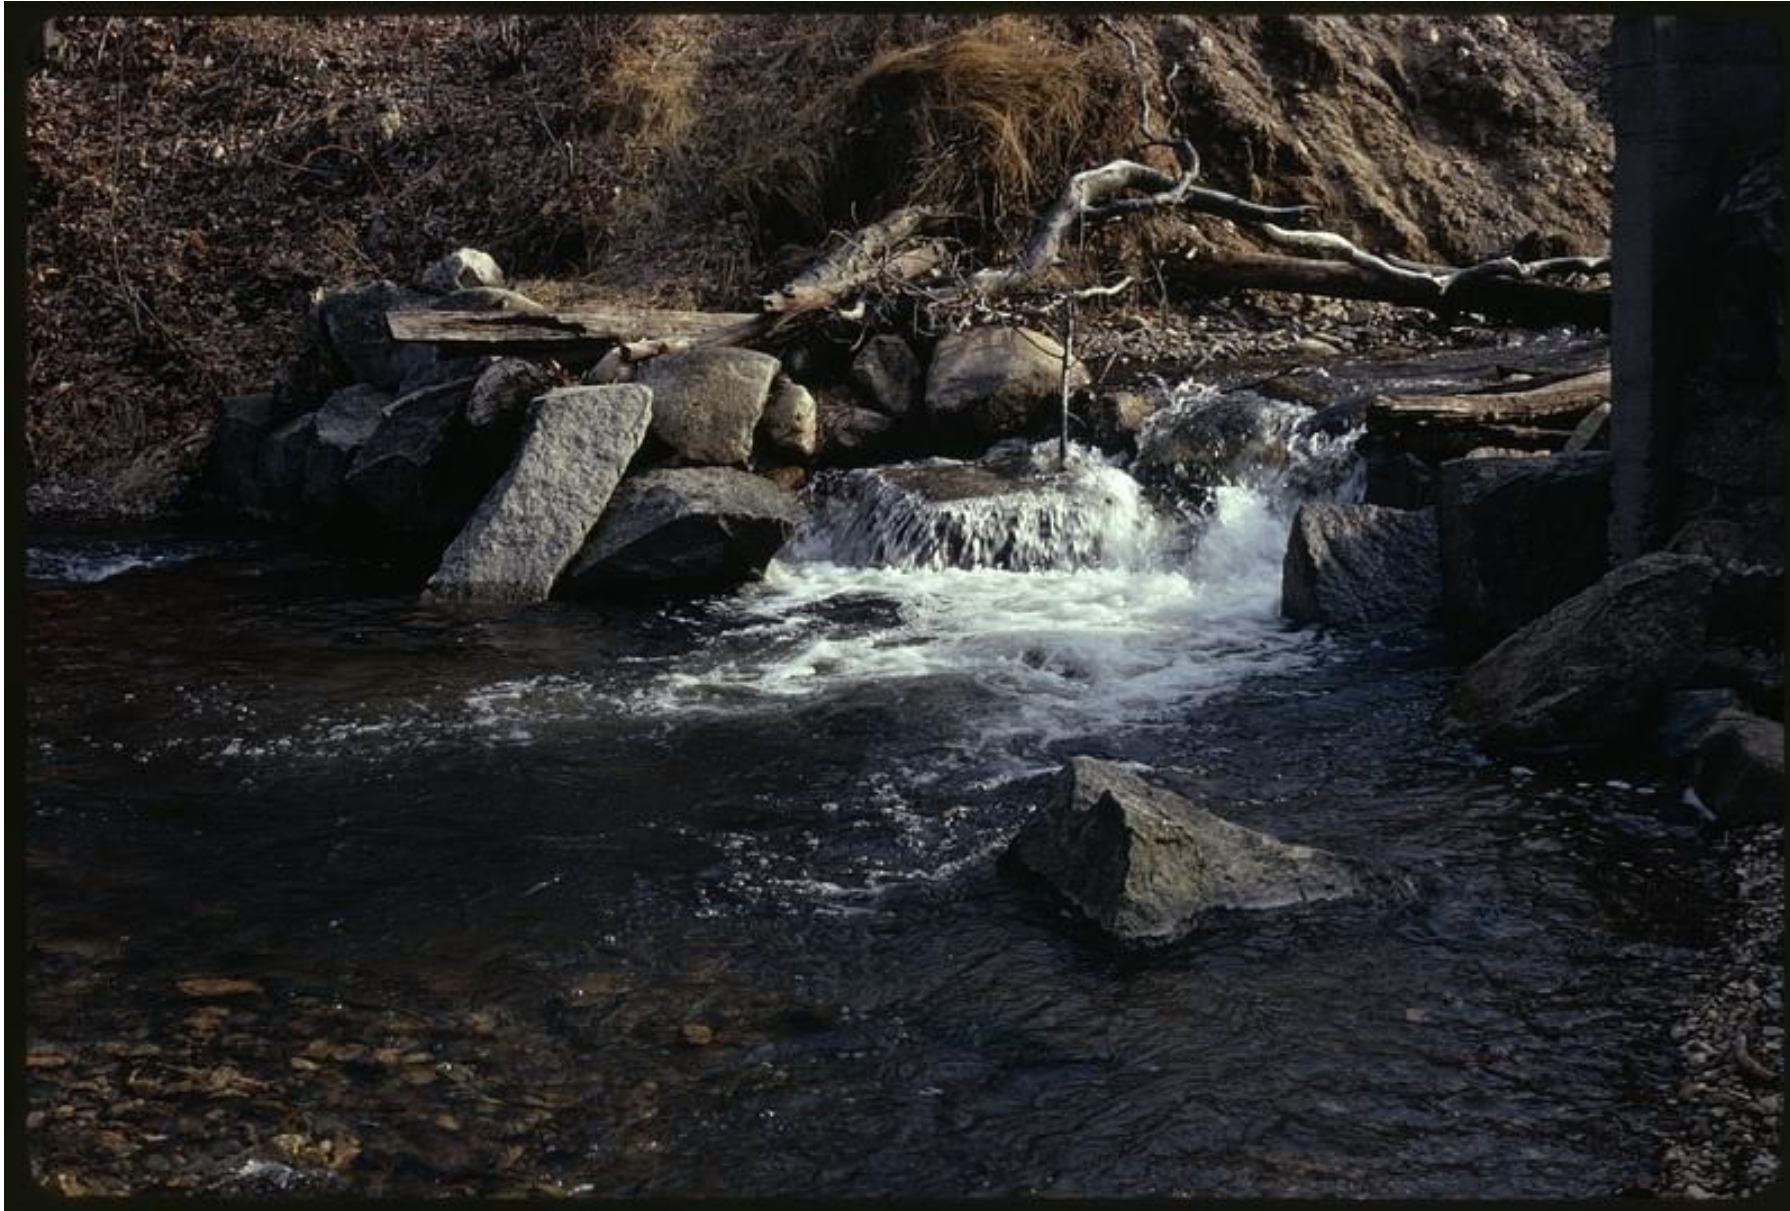
Eagle Dam Breached Condition 1973

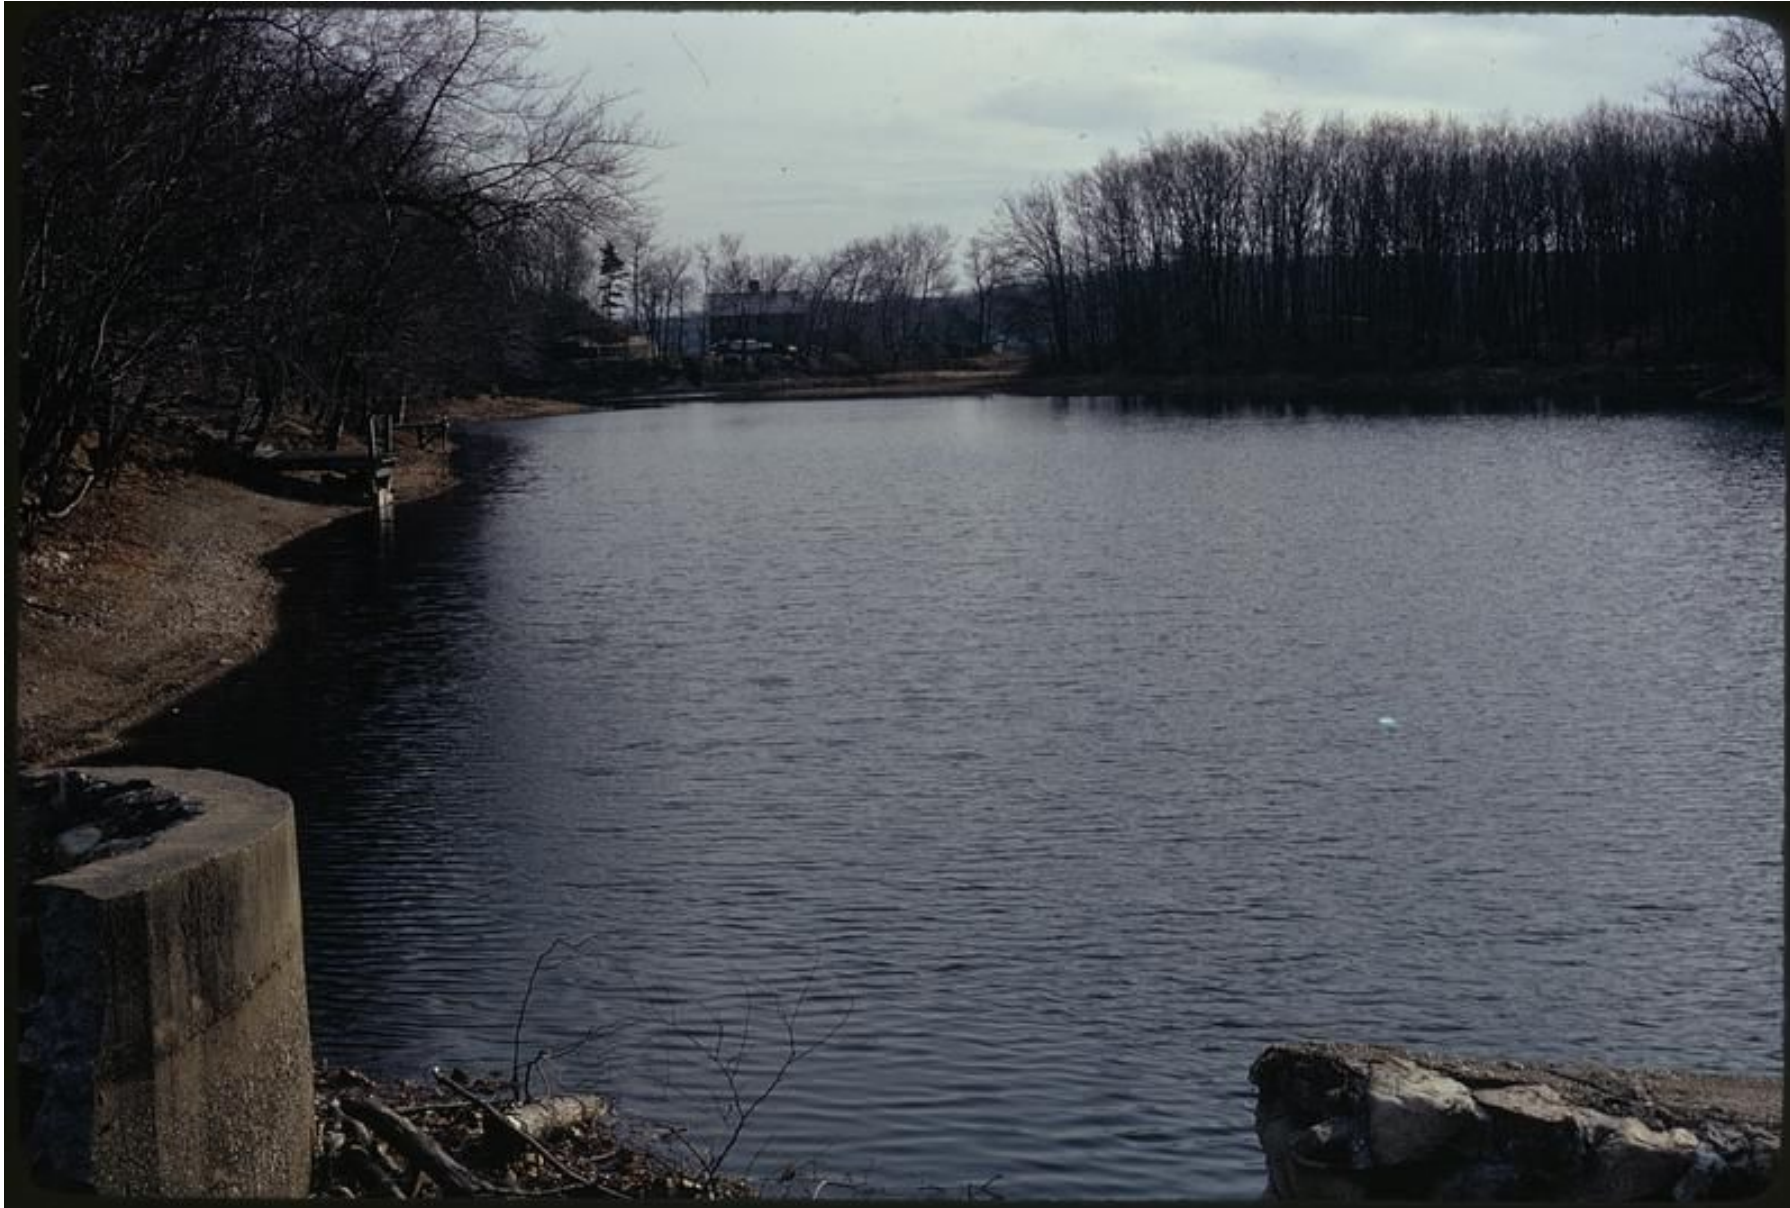
Eagle Dam Breached Condition 1973

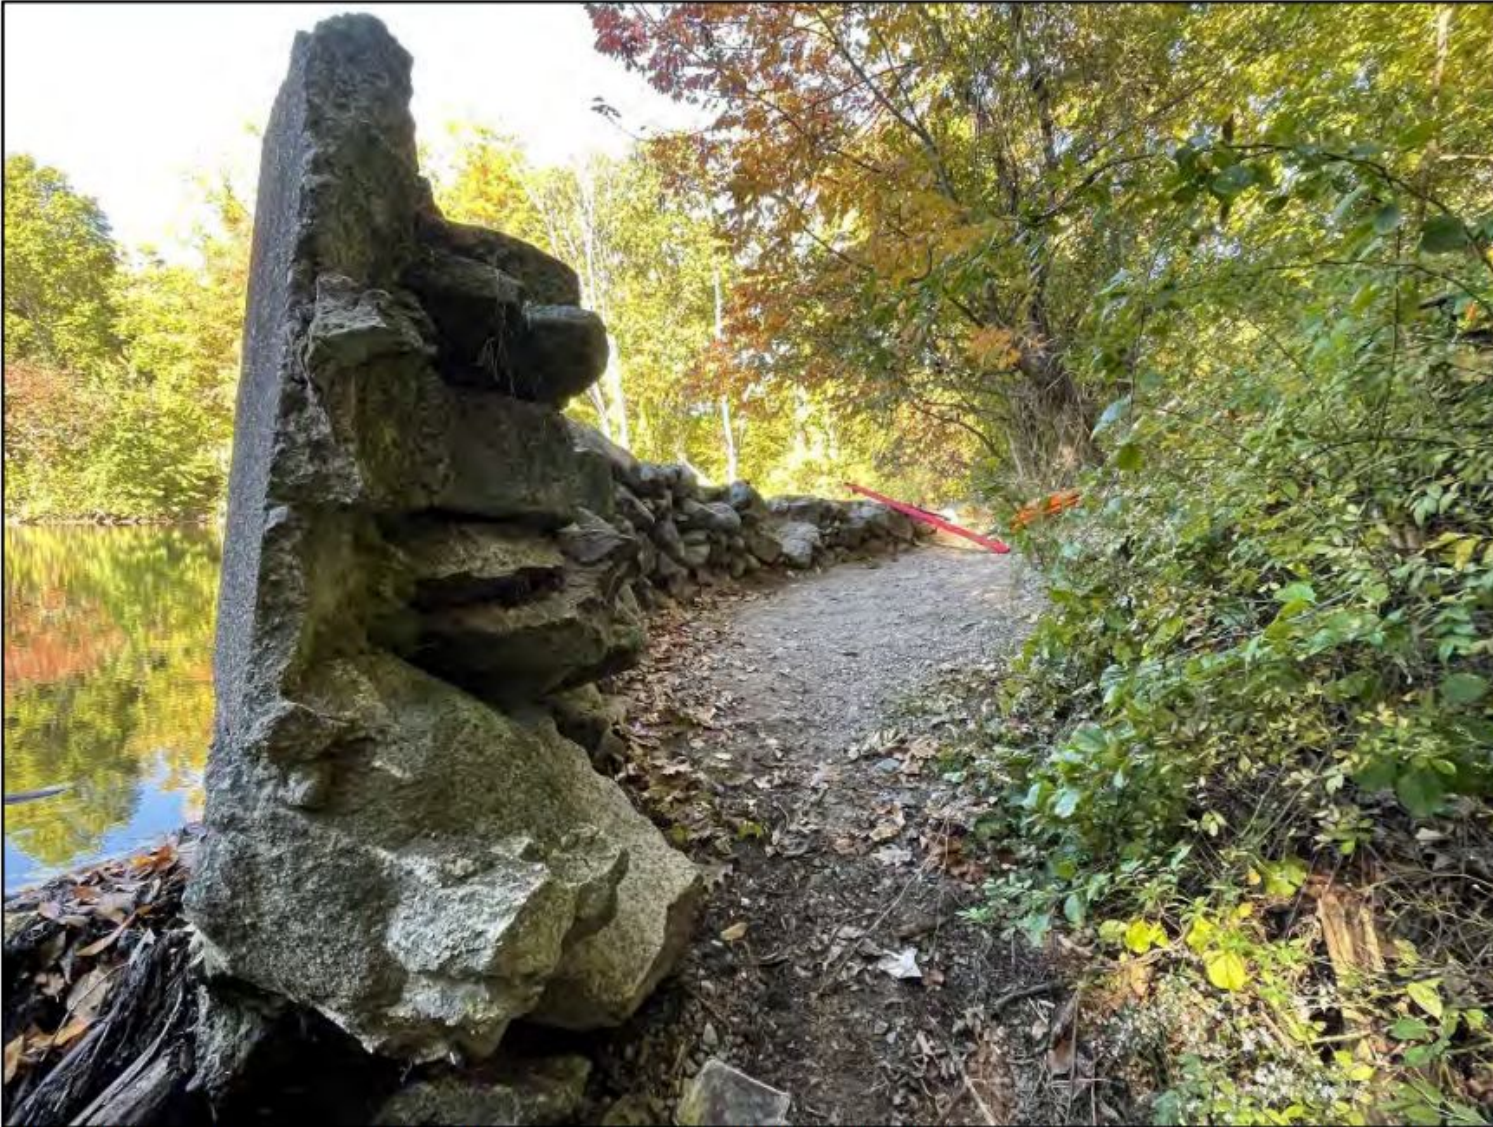
Photo No. 9.: Erosion of the dam crest immediately behind the upstream wall left of the spillway.

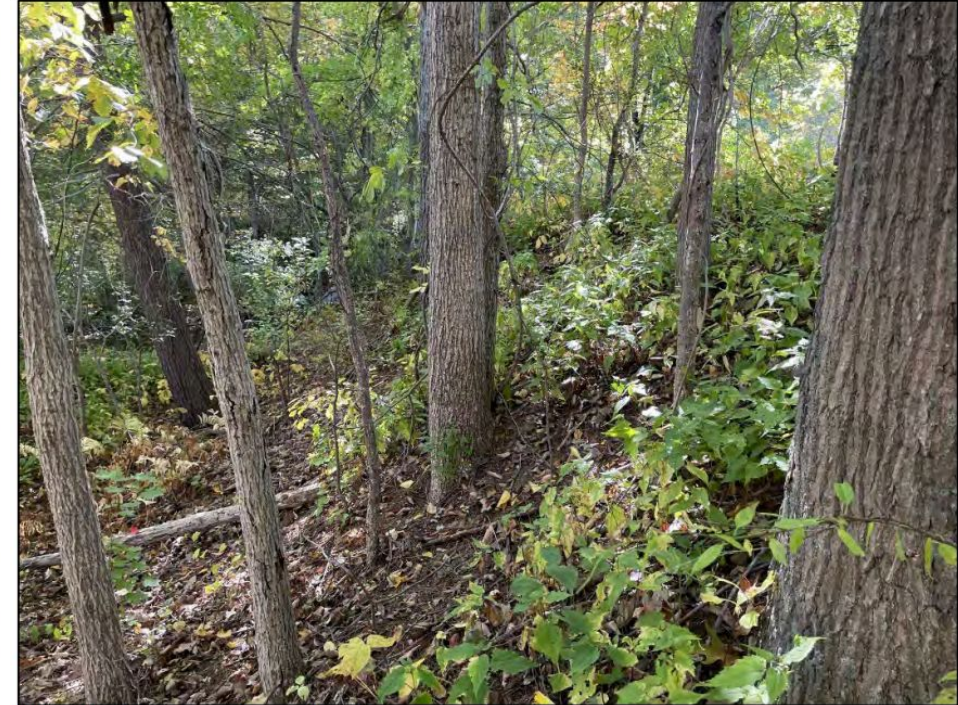
Photo No. 12.: Downstream slope from near Sta. 0+80 looking right.

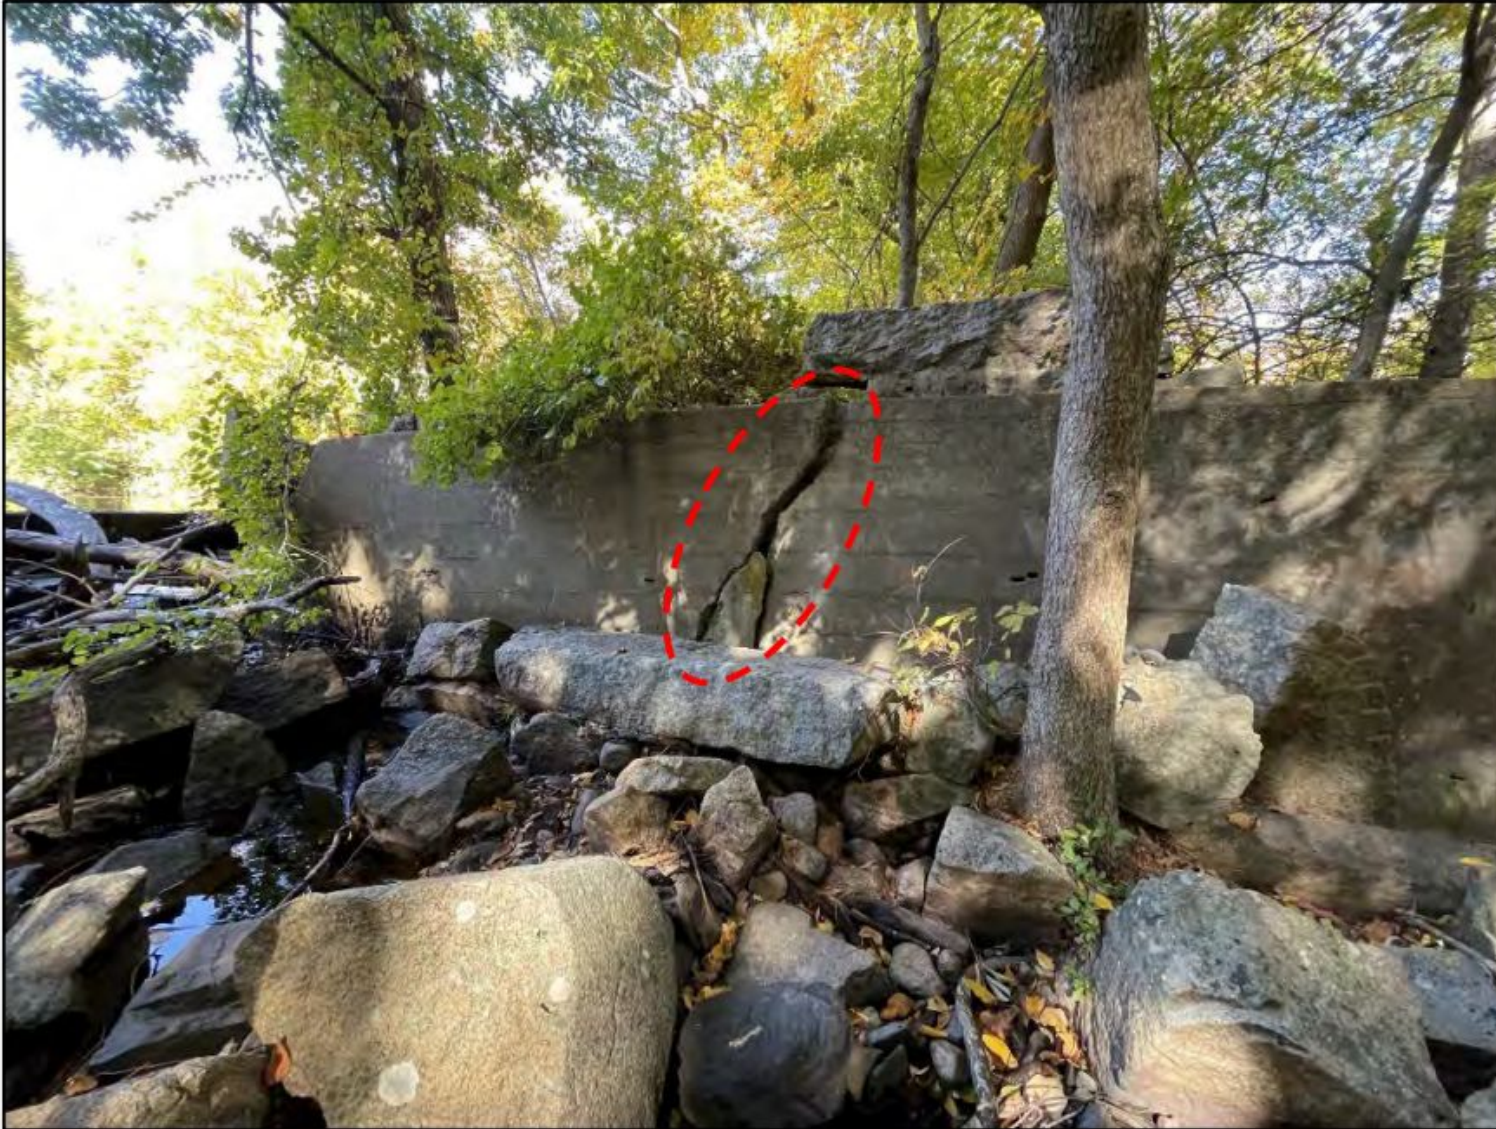
Photo No. 16.: Concrete wall left of the spillway. Note the 5-inch crack.

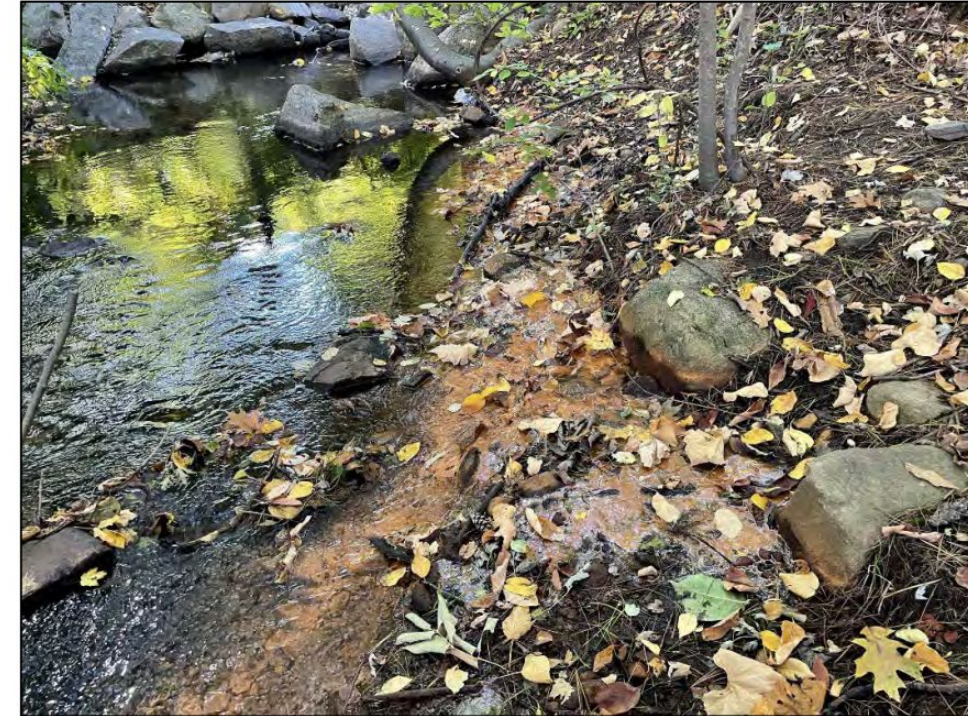
Photo No. 20.: Observed seepages with iron oxide flocculant approximately 15 feet downstream of the downstream channel left wall.

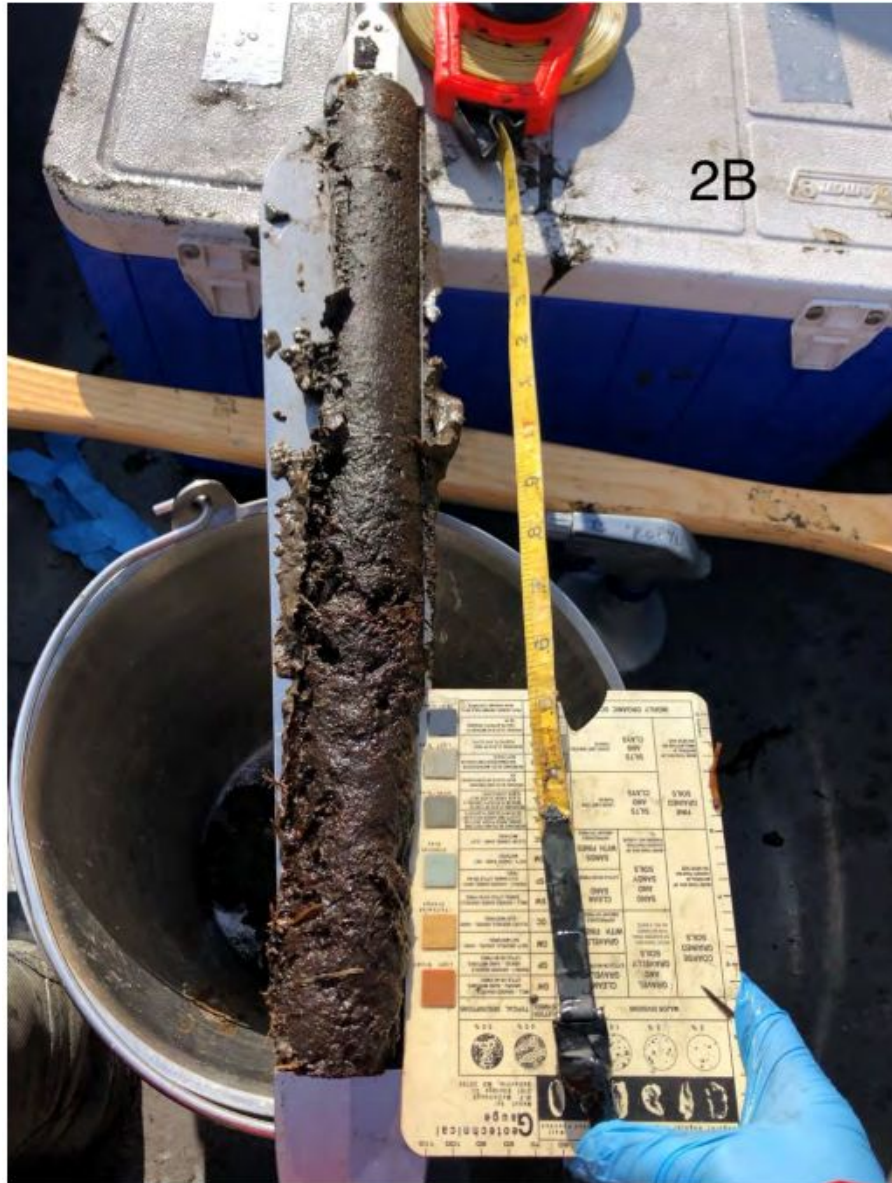
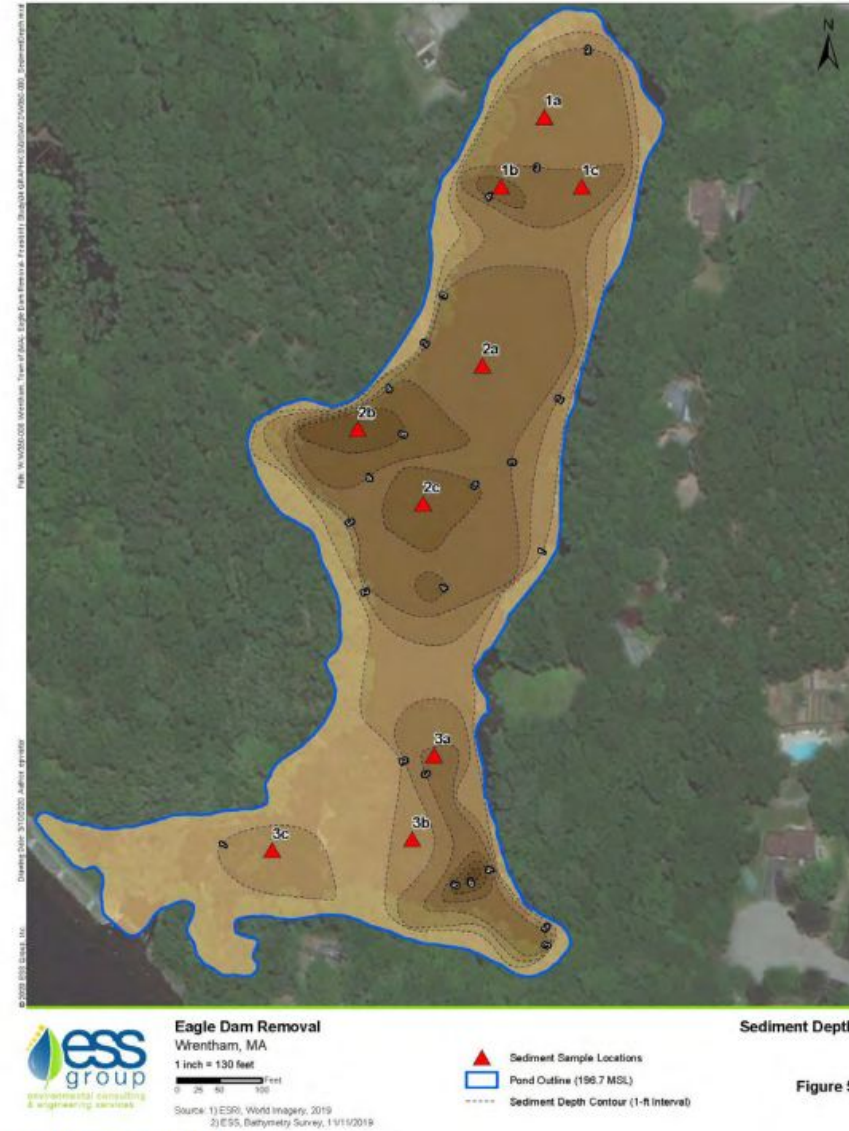
Figure 5. Sediment Depth

2021 ESS Group Feasibility Study - Sediment Sampling
